FINAL REPORT

Aircraft: IKARUS C22

Registration: YR - 5071

No. A 17- 11

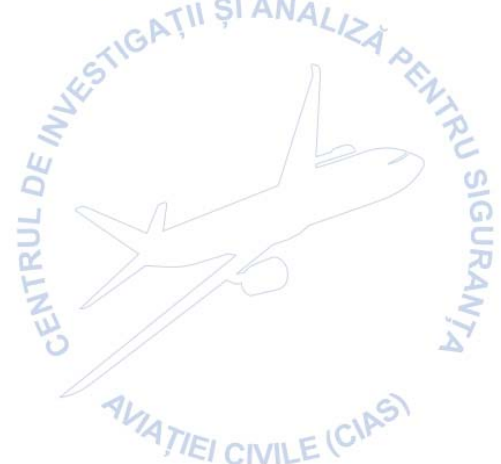
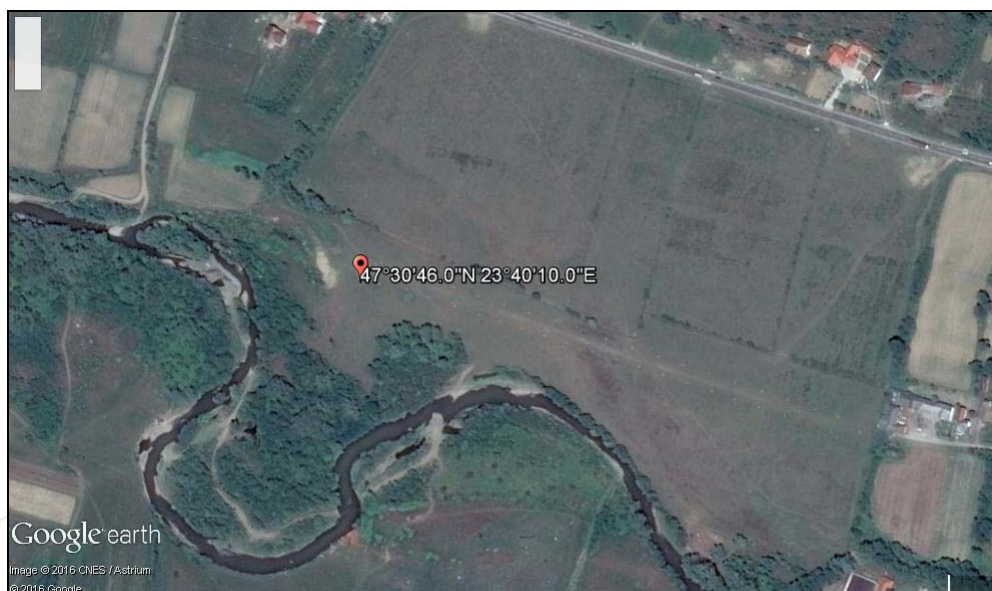
Fig. 1 – Accident site

The aircraft continued the lap, and on the landing slope it entered in a strong dive, had of recovery with gain of height, after which it followed a new pronounced dive. Due to the height of the aircraft, the pilot no longer had the necessary time to control the aircraft evolution and collided the ground at a pronounced diving angle (approx. 70° - 80°).

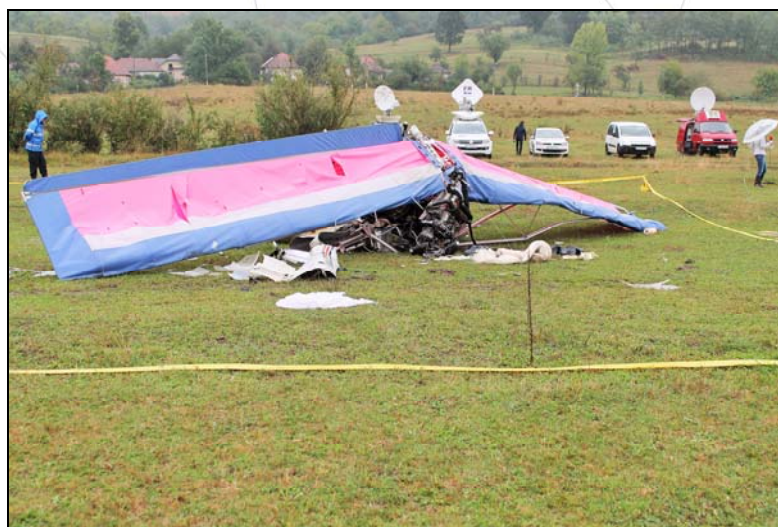
Fig. 2 Aircraft wreckage

The aircraft was totally destroyed.

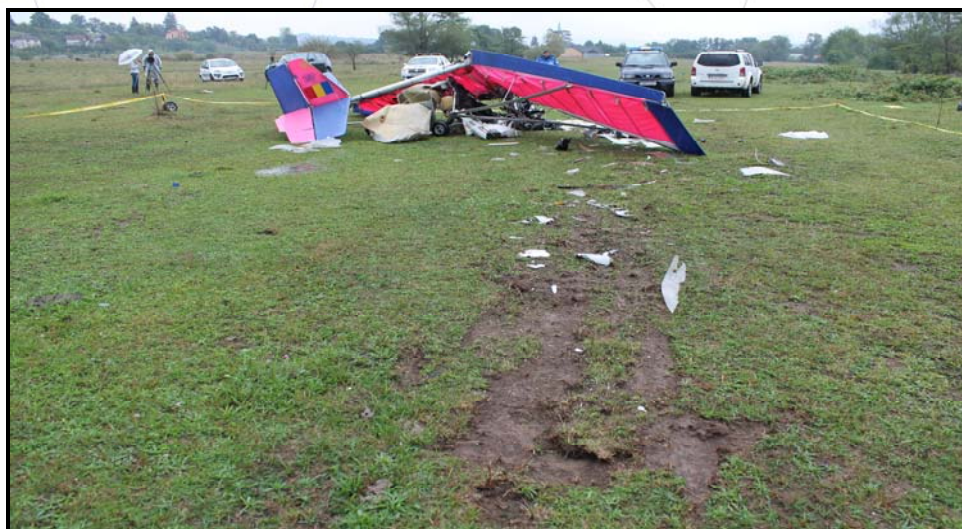
Fig. 8 Impact site

After the ground impact, which occurred on a pronounced dive angle (almost 70° - 80°), the aircraft was totally destroyed.

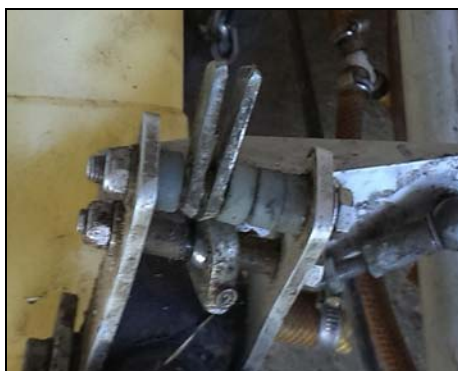
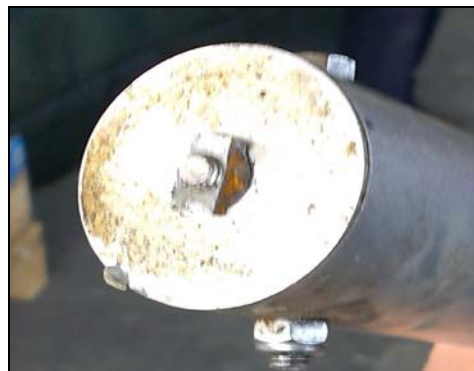
Fig. 9 Front end of connecting rod

A first examination of the aircraft elevator control chain components show that the connecting rod between the stick and the elevator control lever shows, after the accident, different deformations on its two ends: while a rupture appeared at the front end of connecting rod (the two arms of the attaching rod end assembly are broken from their attaching element in the transmission rod) (fig. 9), the attaching element situated on the rear end of the rod, as well as the attaching element of the elevator control lever, do not have any deformations due to impact (fig. 10).

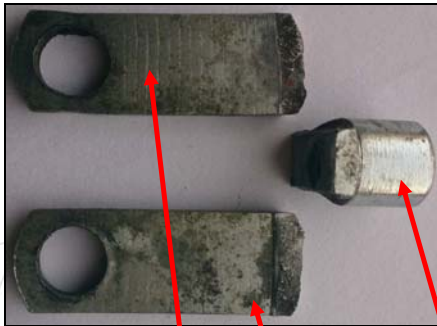
Fig.12 Arm 1

1. the montage position of the attaching rod end assembly was asymmetrical, the four positioning spacers being installed only three, respectively one, on each side of its arms;
2. roundness of a single articular hole, practiced in the shipper arms (see Fig 12, arm 1);
3. deformation of a single hole caused by the rod end attaching axis in the control chain, in front of the arm minimum section (see Arm 1 in Fig. 12);
4. the arms rupture surfaces have a degree of asymmetry and a different morphology, as follows:

- a) Arm 1 presents on the rupture surface rust traces, presenting both smooth and rough areas, characteristic of a fatigue rupture;
 - b) Arm 2 presents a rupture surface without rust traces, with a relatively uniform harsh aspect, characteristic of a sudden rupture;
5. the surface of rod end attaching element shows a shiny aspect, as a result of operating friction with the following component of the control chain, made of an alloy of Al, directly coming in contact with;
 6. the hole of the rod end attaching axis from the Al alloy is not deformed.

2. The two arms of the attaching rod end broke, **one of them breaking due to fatigue (arm 1)**, and the other one not being sized to integrally take-over the operating stresses, given the asymmetrical montage / operation conditions, **suddenly breaking (arm 2)**;

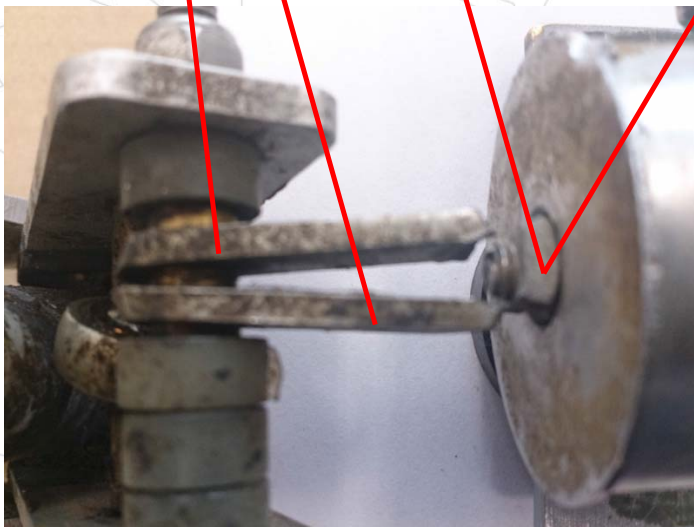
Fig. 14 Attaching rod end assembly

1. After the macroscopic analysis of the component called attaching rod end assembly, from the elevator control chain, show that it functioned asymmetrically, due to montage position, being stressed in an unbalanced way to forces and torques that led to the accumulation of uneven tensions in the two arms, causing its rupture;

The metallurgical analysis conclusion is that the incorrect (asymmetrical) montage of the attaching rod end assembly caused the rupture of arm no. 1 in time (fatigue rupture), but arm no. 2 suddenly broke (most likely at the aircraft impact with the ground).

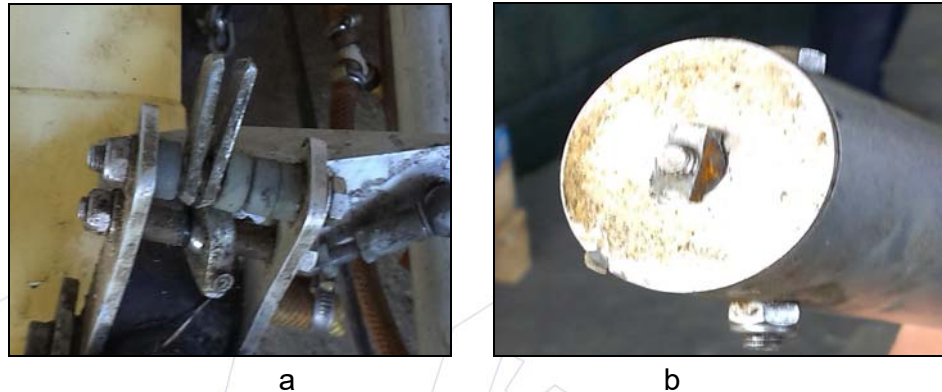
Fig. 15 Front end of connecting rod

In case of the front end of connecting rod (figure 15), the two arms of the rod end assembly (detail a) are detached (broken) from its attaching element (detail b).

After the performed metallurgical analyzes, the investigation commission considers that the incorrect (asymmetrical) montage of the attaching rod end assembly did not influence the accident from 23.08.2014. As a result of the incorrect montage position and the operating stresses, its operation was asymmetrical, and in time it led to the rupture of an arm of the attaching rod end assembly, in such way that the operation of the elevator control chain was provided only by one arm of the attaching rod end assembly.

The command transmission from stick to the elevator functioned, but the failure to correct this defect could have led to the rupture of the second arm and, thus, to the elevator control loss

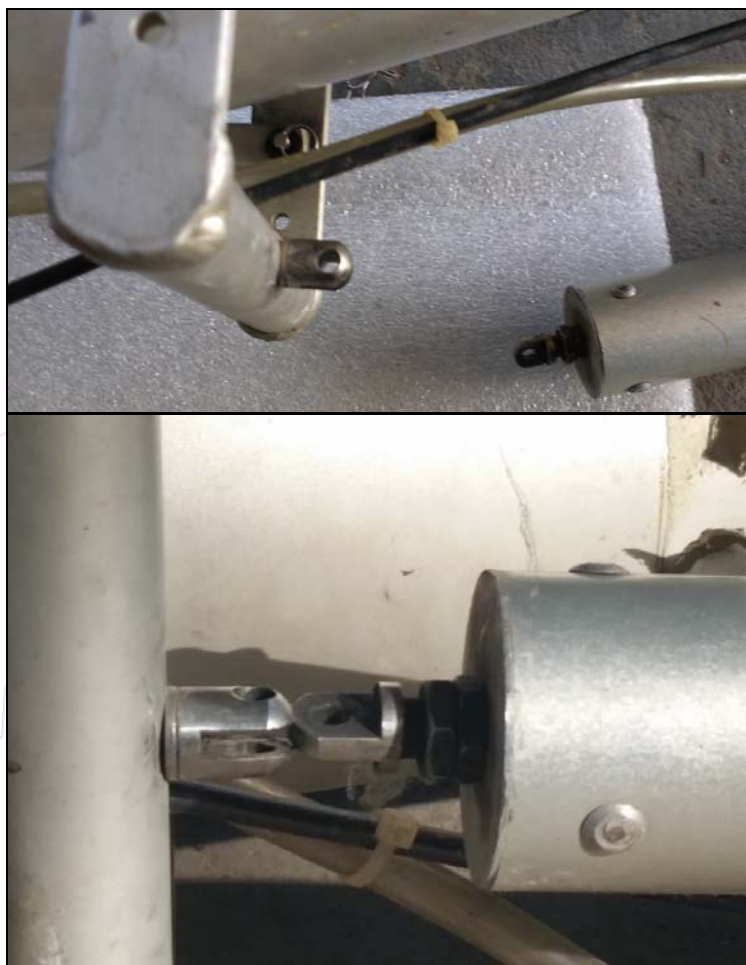
Fig. 16 Connecting rod rear end and elevator control lever

The attaching element situated at the rod rear end, as well as the attaching element of the elevator control lever, show no deformations resulting from the impact (see figure 16).

By analyzing condition in which these components have been found after the accident, it can be concluded that, while the front of transmission rod was attached to the stick assembly, the rear end and the elevator control lever were not connected, the attaching bolt of the two elements not being present, most likely detaching before the accident.

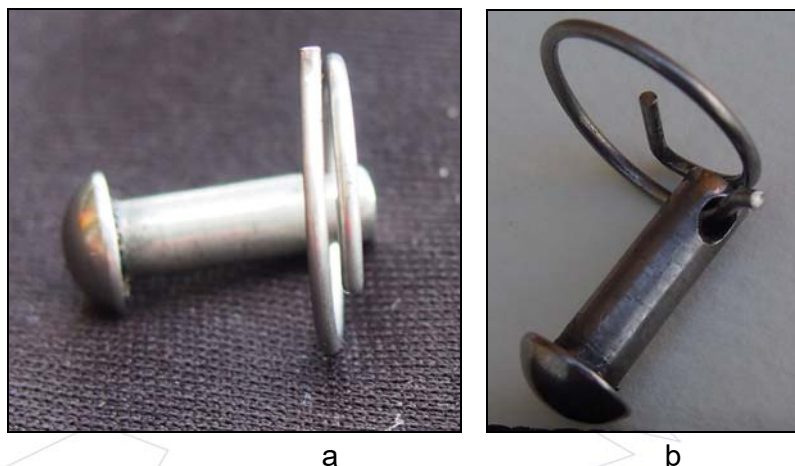
Fig. 17 Safety ring distance

This detachment could have been also favored by the bolt operation wear (respectively of the hole destined for the attachment of safety ring), as well as by the loss of calibration of the safety ring respectively the size of the distance between the safety spires – see figure 17 b).

- detail a – new bolt, new ring (correct distance between spires)
- detail b – used bolt and hole, used ring (increased distance between spires, possibility of detaching)

1. It is recommended to the aircraft manufacturer, COMCO IKARUS GmbH, to amend the operation and maintenance manual of this aircraft type on the mandatory replacement of the attaching bolts safety rings from different aircraft components each time these bolts are removed or to issue an informative bulletin in this respect.

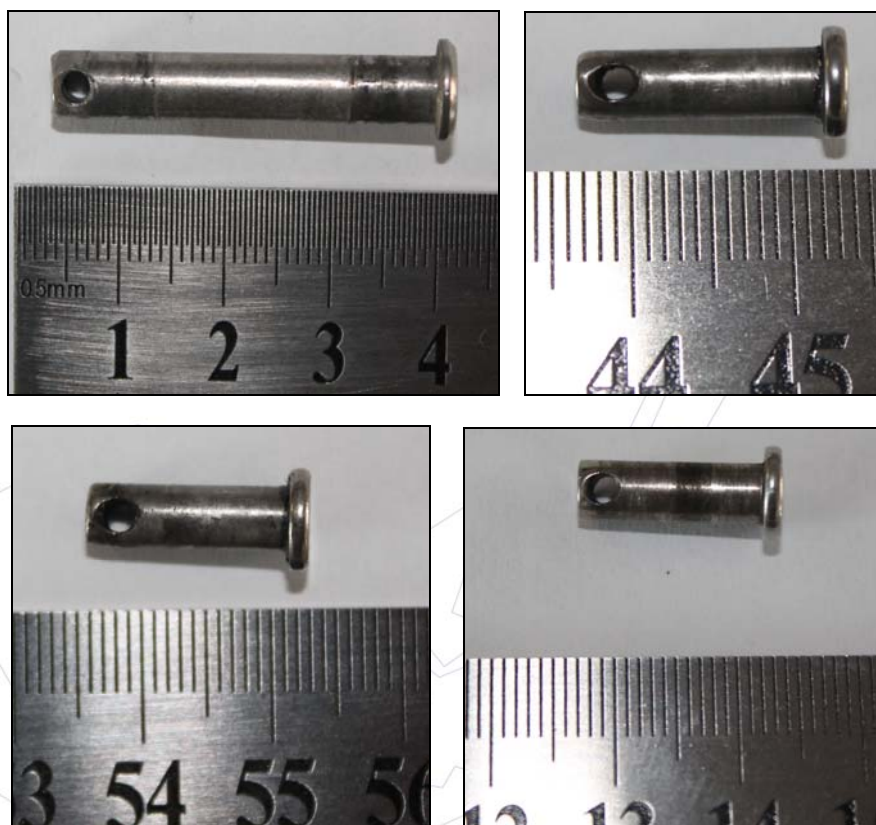
Fig. 19 The attaching bolts used on YR-5071

Because in the logbook of YR-5071 aircraft there are not mentioned any attaching bolts replacements that would have been performed during different maintenance works, it can be assumed that the bolts mounted on the aircraft involved in the accident have the same usage duration, this including also the bolt that should have been mounted to connect the control rod with the elevator control lever.
