FINAL REPORT

Aircraft: IKARUS C22

Registration: YR - 5071

No. A 17- 11

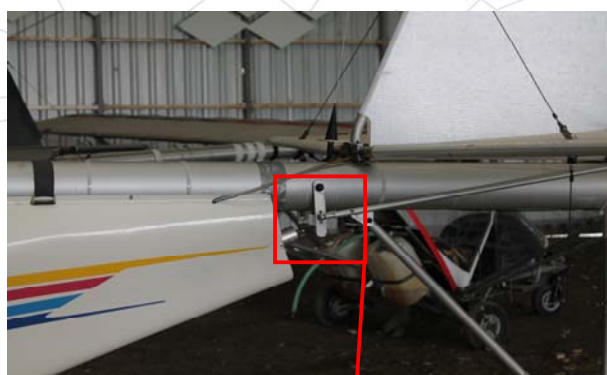
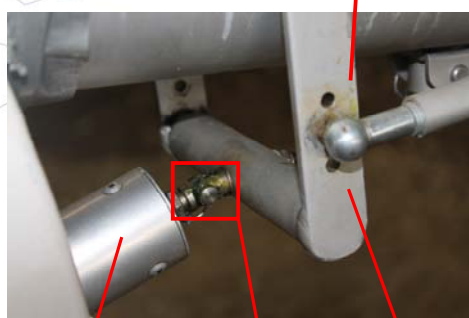
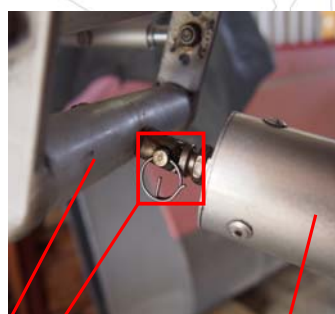
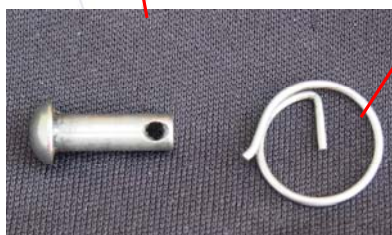
Fig. 7 Connecting rod and elevator pushrod – connecting chain

At the rear end, the connecting rod is linked to the elevator pushrod through a bolt that is secured by a safety ring.

bolt+safety ring to attach the connecting rod with elevator control lever

By analyzing condition in which these components have been found after the accident, it can be concluded that, while the front of transmission rod was attached to the stick assembly, the rear end and the elevator control lever were not connected, the attaching bolt of the two elements not being present, most likely detaching before the accident.

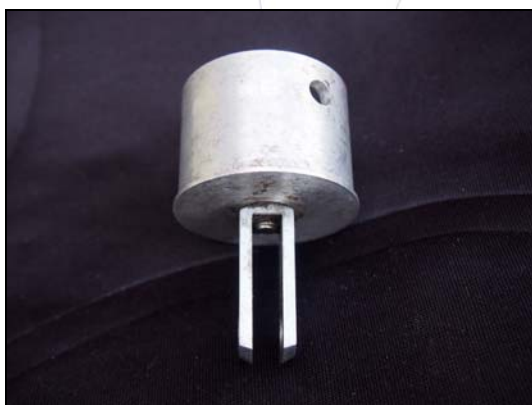
Fig. 11 Attaching rod end assembly – new component

It was performed a metallurgical analysis of a component in the aircraft elevator control chain, called the *attaching rod end assembly* (see fig. 11), situated at the rear end of the main control rod, in order to determine the causes of the rupture occurred at the front end of connecting rod.

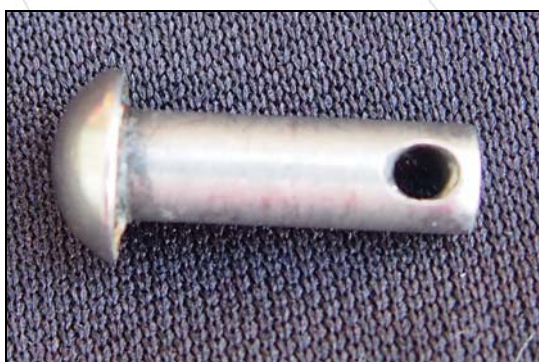
Fig. 18 Unused attaching bolt

To observe the differences between a bolt without wear and a bolt that was subject to wear appearing after prolonged operation on aircraft, in the figures below there are presented a bolt without wear and a few attaching bolts used on YR-5071 aircraft, removed after the accident .

Because in the logbook of YR-5071 aircraft there are not mentioned any attaching bolts replacements that would have been performed during different maintenance works, it can be assumed that the bolts mounted on the aircraft involved in the accident have the same usage duration, this including also the bolt that should have been mounted to connect the control rod with the elevator control lever.
